HOUSE DAMAGE ASSESSMENT

URS Research Company

Defense Nuclear Agency

June 1972

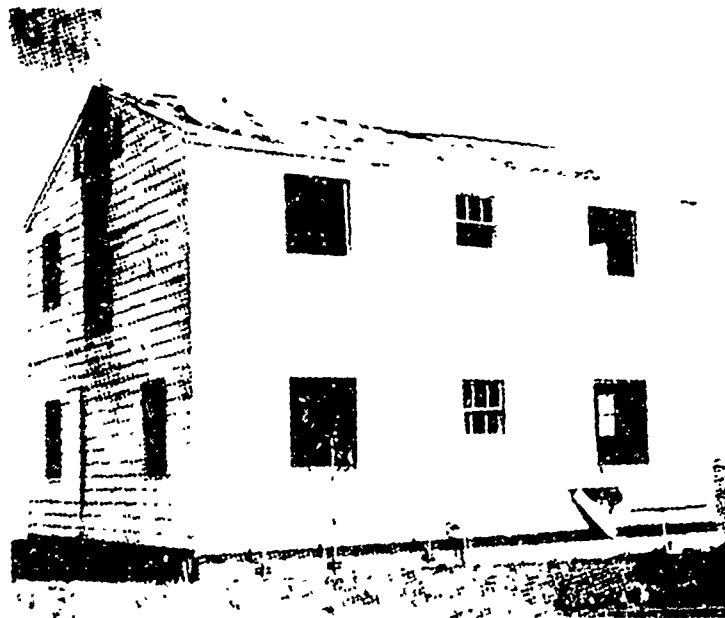
Fig. 6-9. House Damage Summary, House No. I-9

ITEM	DAMAGE PERCENT (each element)	CHANGE PERCENT (total value)
Floor and Ceiling Framing	0	0
Roof Framing and Roof Surface	60	4.2
Exterior and Interior Wall Framing	23	3.7
Interior Plaster	40	4.4
Exterior Sheathing and Siding	20	1.7
Doors	67	3.1
Windows	93	4.5
Foundation and Basement	0	0
Misc.: Stairs, Fireplace, Paint, Trim	30	3.6
TOTAL		25.2

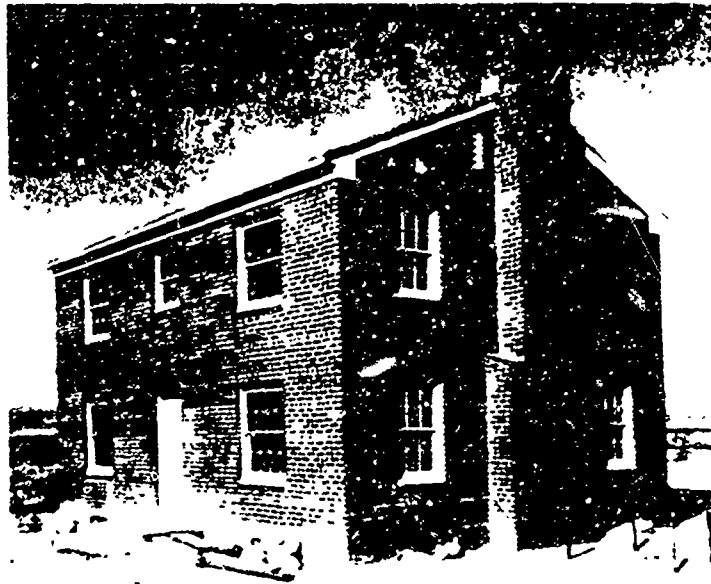
Fig. 6-12. House Damage Summary, House No. II-1

ITEM	DAMAGE PERCENT (each element)	CHANGE PERCENT (total value)
Floor and Ceiling Framing	12	2.0
Roof Framing and Roof Surface	30	2.1
Exterior and Interior Wall Framing	0	0
Interior Plaster	15	1.7
Exterior Sheathing and Siding	0	0
Doors	17	0.8
Windows	80	3.8
Foundation and Basement	0	0
Misc.: Stairs, Fireplace, Paint, Trim	1	<u>0.5</u>
TOTAL		10.9

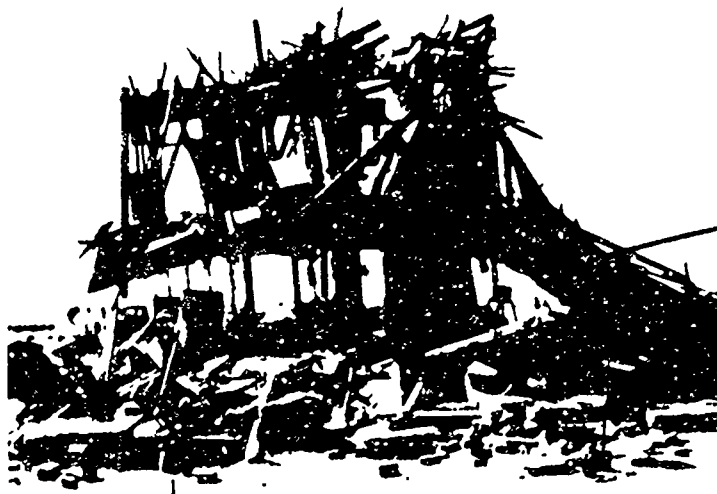
Fig. 6-13. House Damage Summary, House No. II-2

ITEM	DAMAGE PERCENT (each element)	CHANGE PERCENT (total value)
Floor and Ceiling Framing	100	17.0
Roof Framing and Roof Surface	100	7.0
Exterior and Interior Wall Framing	100	16.0
Interior Plaster	100	11.0
Exterior Sheathing and Siding	100	8.6
Doors	100	4.6
Windows	100	4.8
Foundation and Basement	2	0.4
Misc.: Stairs, Fireplace, Paint, Trim	100	12.0
TOTAL		81.4

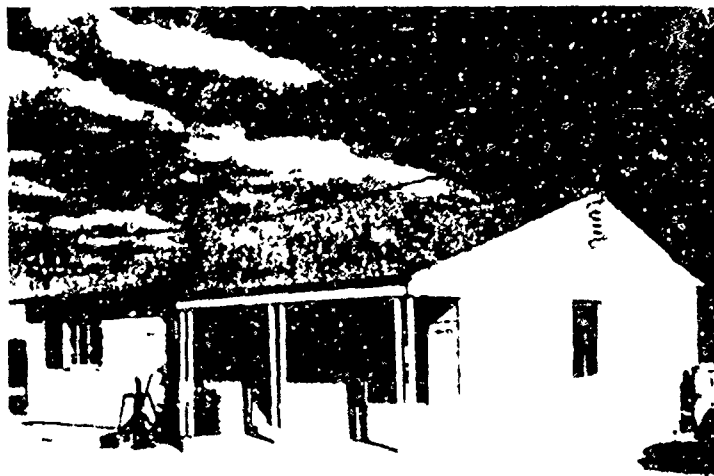
Fig. 6-16. House Damage Summary, House No. 111-1

ITEM	DAMAGE PERCENT (each element)	CHANGE PERCENT (total value)
Floor and Ceiling Framing	0	0
Roof Framing and Roof Surface	10	0.7
Exterior and Interior Wall Framing	10	1.6
Interior Plaster	30	3.3
Exterior Sheathing and Siding	0	0
Doors	10	0.5
Windows	80	3.8
Foundation and Basement	0	0
Misc.: Stairs, Fireplace, Paint, Trim	15	1.8
TOTAL		11.7

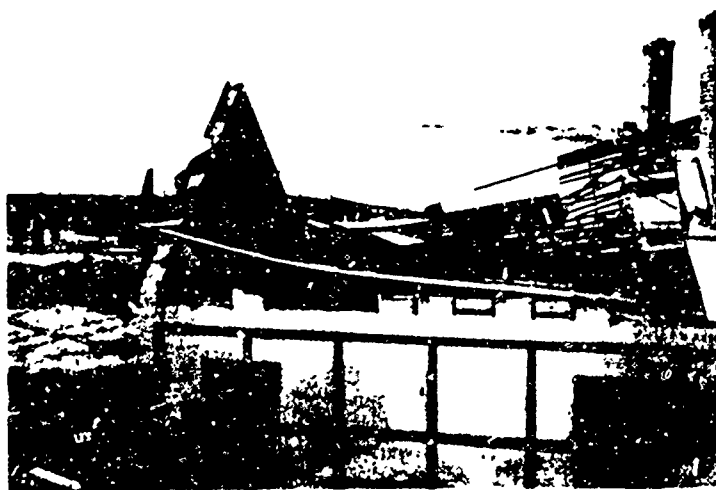
Fig. 6-18. House Damage Summary, House No. IV-1

ITEM	DAMAGE PERCENT (each element)	CHANGE PERCENT (total value)
Floor and Ceiling Framing	10	1.7
Roof Framing and Roof Surface	100	7.0
Exterior and Interior Wall Framing	20	3.2
Interior Plaster	20	2.2
Exterior Sheathing and Siding	10	0.9
Doors	25	1.2
Windows	80	3.8
Foundation and Basement	0	0
Misc.: Stairs, Fireplace, Paint, Trim	25	<u>3.0</u>
TOTAL		23.0

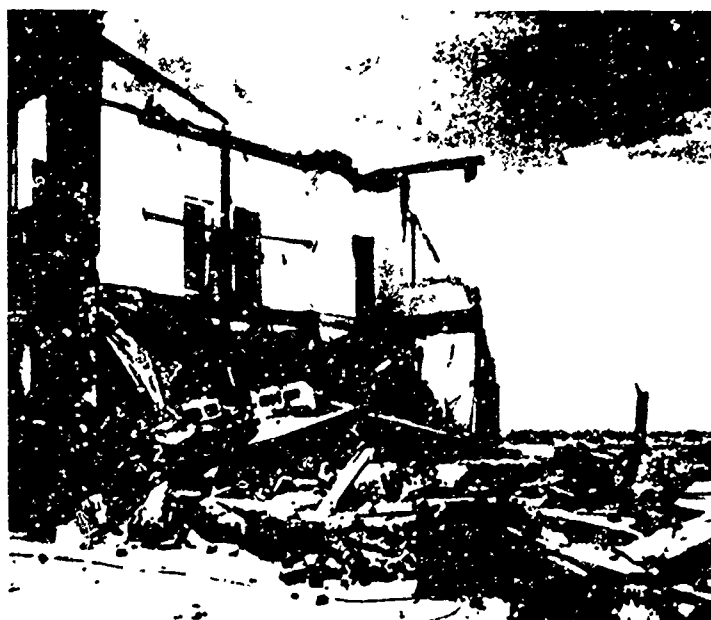
Fig. 6-19. House Damage Summary, House No. IV-2

ITEM	DAMAGE PERCENT (each element)	CHANGE PERCENT (total value)
Floor and Ceiling Framing	60	10.2
Roof Framing and Roof Surface	100	7.0
Exterior and Interior Wall Framing	50	8.0
Interior Plaster	60	6.6
Exterior Sheathing and Siding	50	4.3
Doors	100	4.6
Windows	100	4.8
Foundation and Basement	10	1.9
Misc.: Stairs, Fireplace, Paint, Trim	50	6.0
TOTAL		53.4

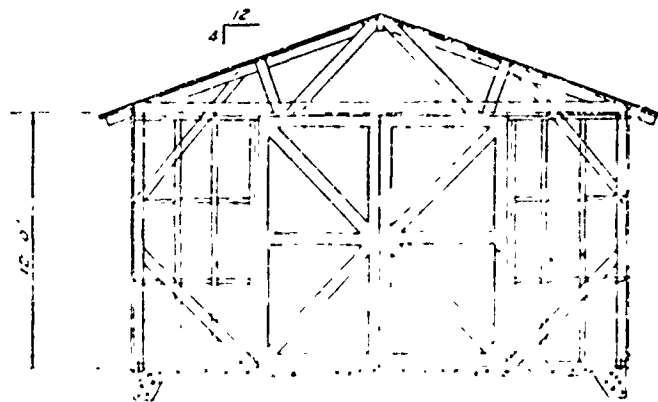
Warehouses, Structural Damage

The construction details are shown below. The framing consisted of 2- x 4-in. studs, and 2- x 4-in. trussed rafters with a 2- x 6-in. bottom chord 2 ft o.c. and with a 2- x 4-in. knee bracing 8 ft o.c. The siding was 3/8-in. exterior plywood and the roofing was of corrugated aluminum sheet metal secured to 1- x 4-in. nailing strips. The size of the building was estimated to be 25 x 60 ft.
